VOLUME V

TITANIUM DEVELOPMENT PROGRAM

GENERAL DYNAMICS/CONVAIR
A Division of General Dynamics Corporation

FINAL TECHNICAL ENGINEERING REPORT
December 1957 - May 1961

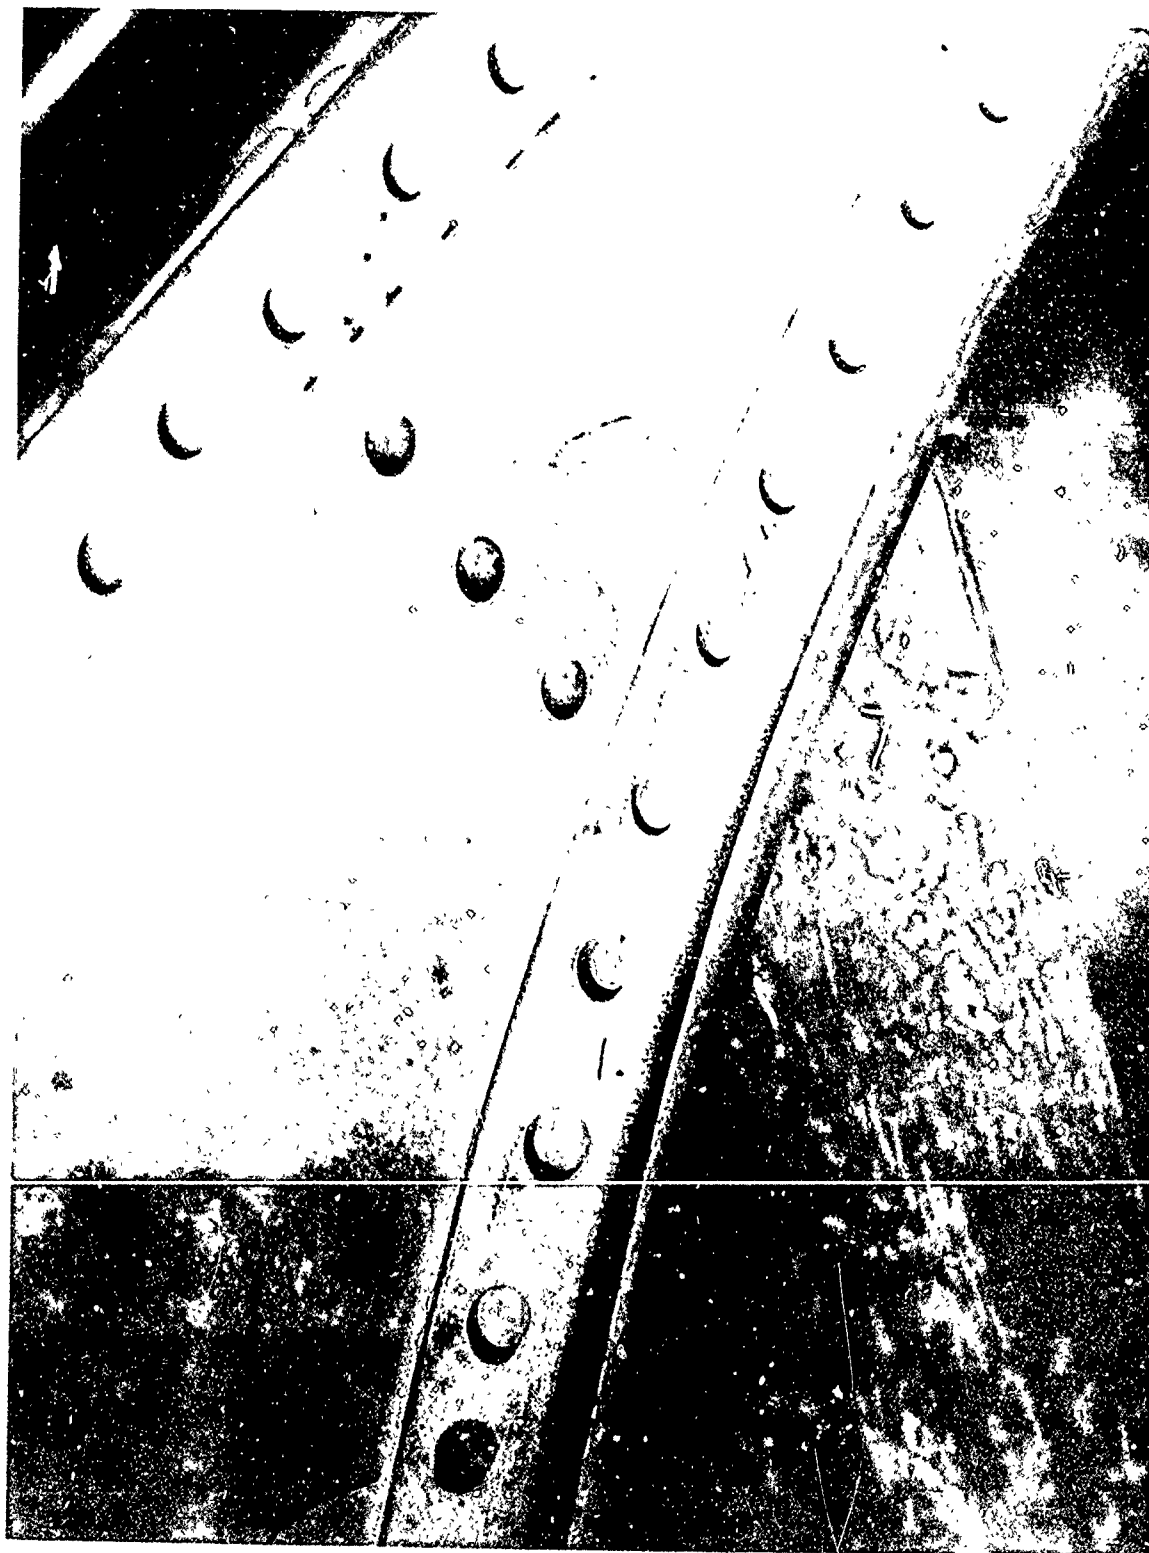
Convair Print 63962
Figure A-90 - RIVETED FUSELAGE CANTED BULKHEAD ASSEMBLY;
Inner Flange Fatigue Failure After 140, 629 Cycles.

Fatigue	800	66.6	4000	140,629	88 thru 92	Web Failures. Specimen will sustain load. Test discontinued.

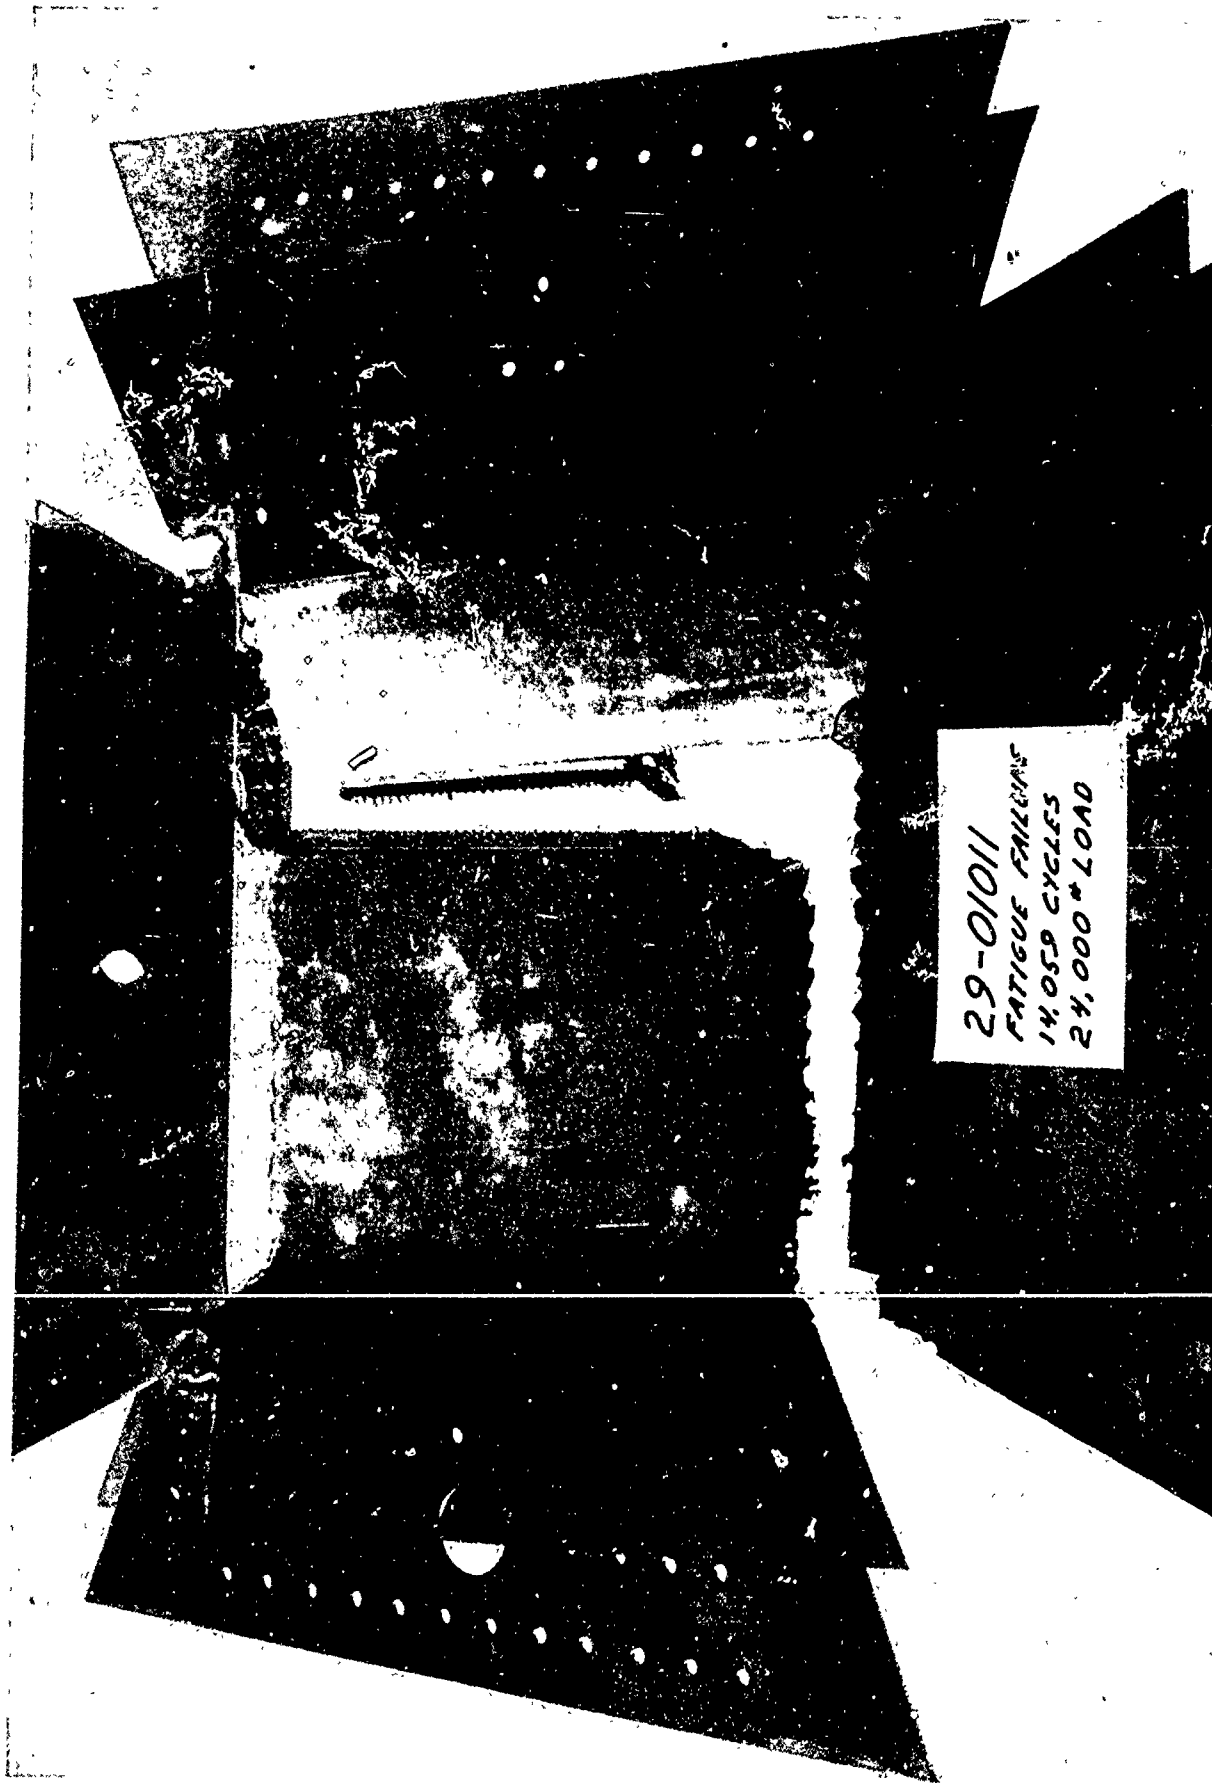
Figure D-23 -- FATIGUE FAILURE OF 29-01011 PANEL; Unstiffened Side.

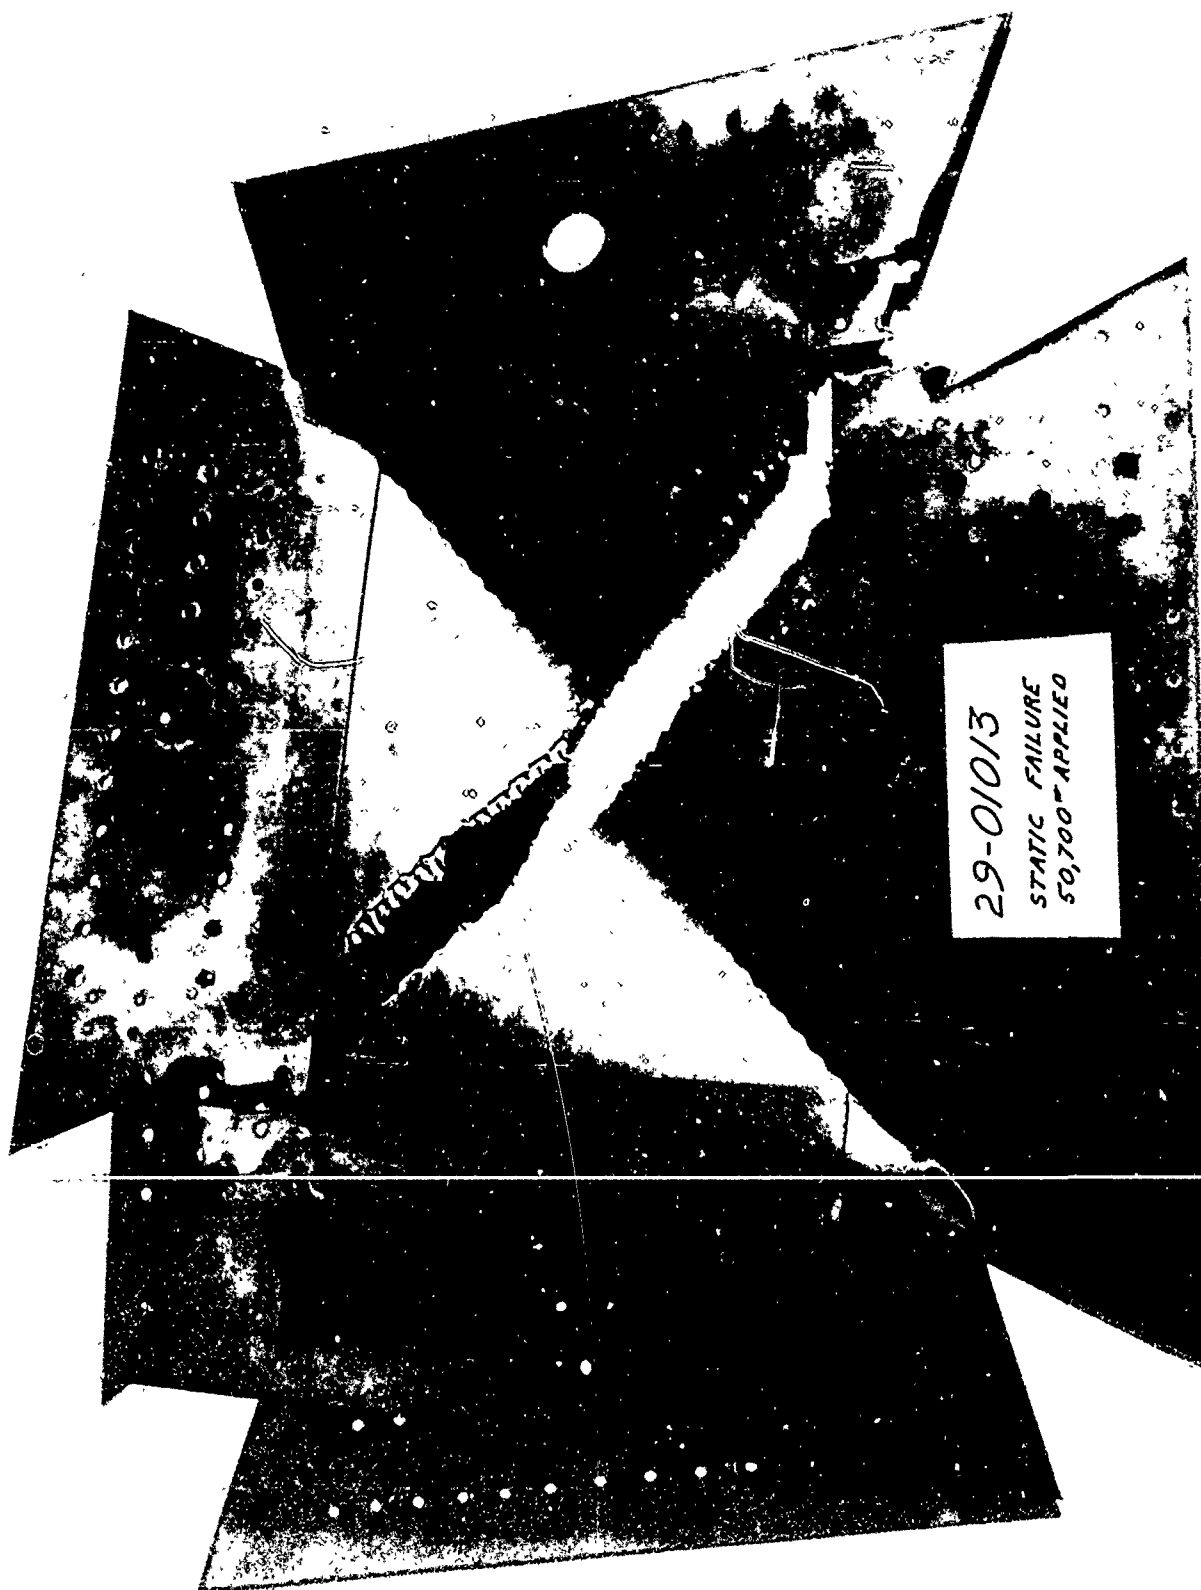
Figure D-26 — STATIC FAILURE OF 29-01013 PANEL; Unstiffened Side.

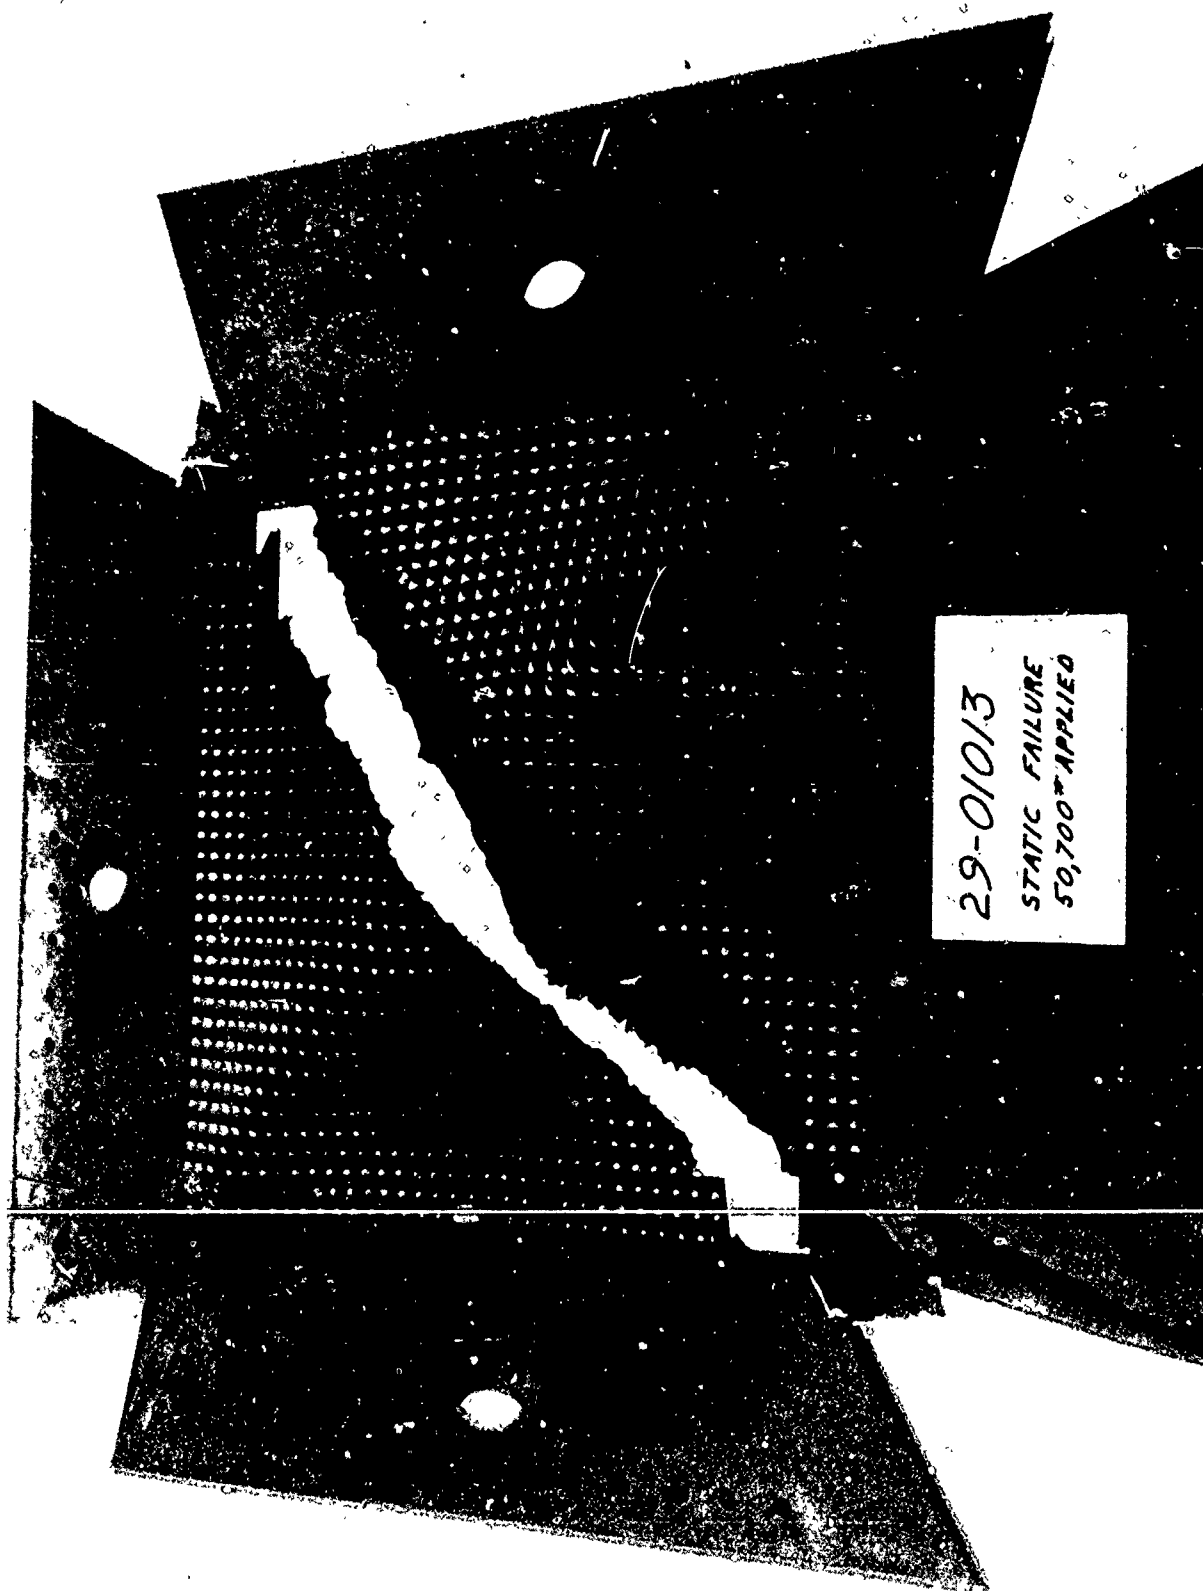
Figure D-27 — STATIC FAILURE OF 29-01013 PANEL. Stiffened Side. Convair Print 66369

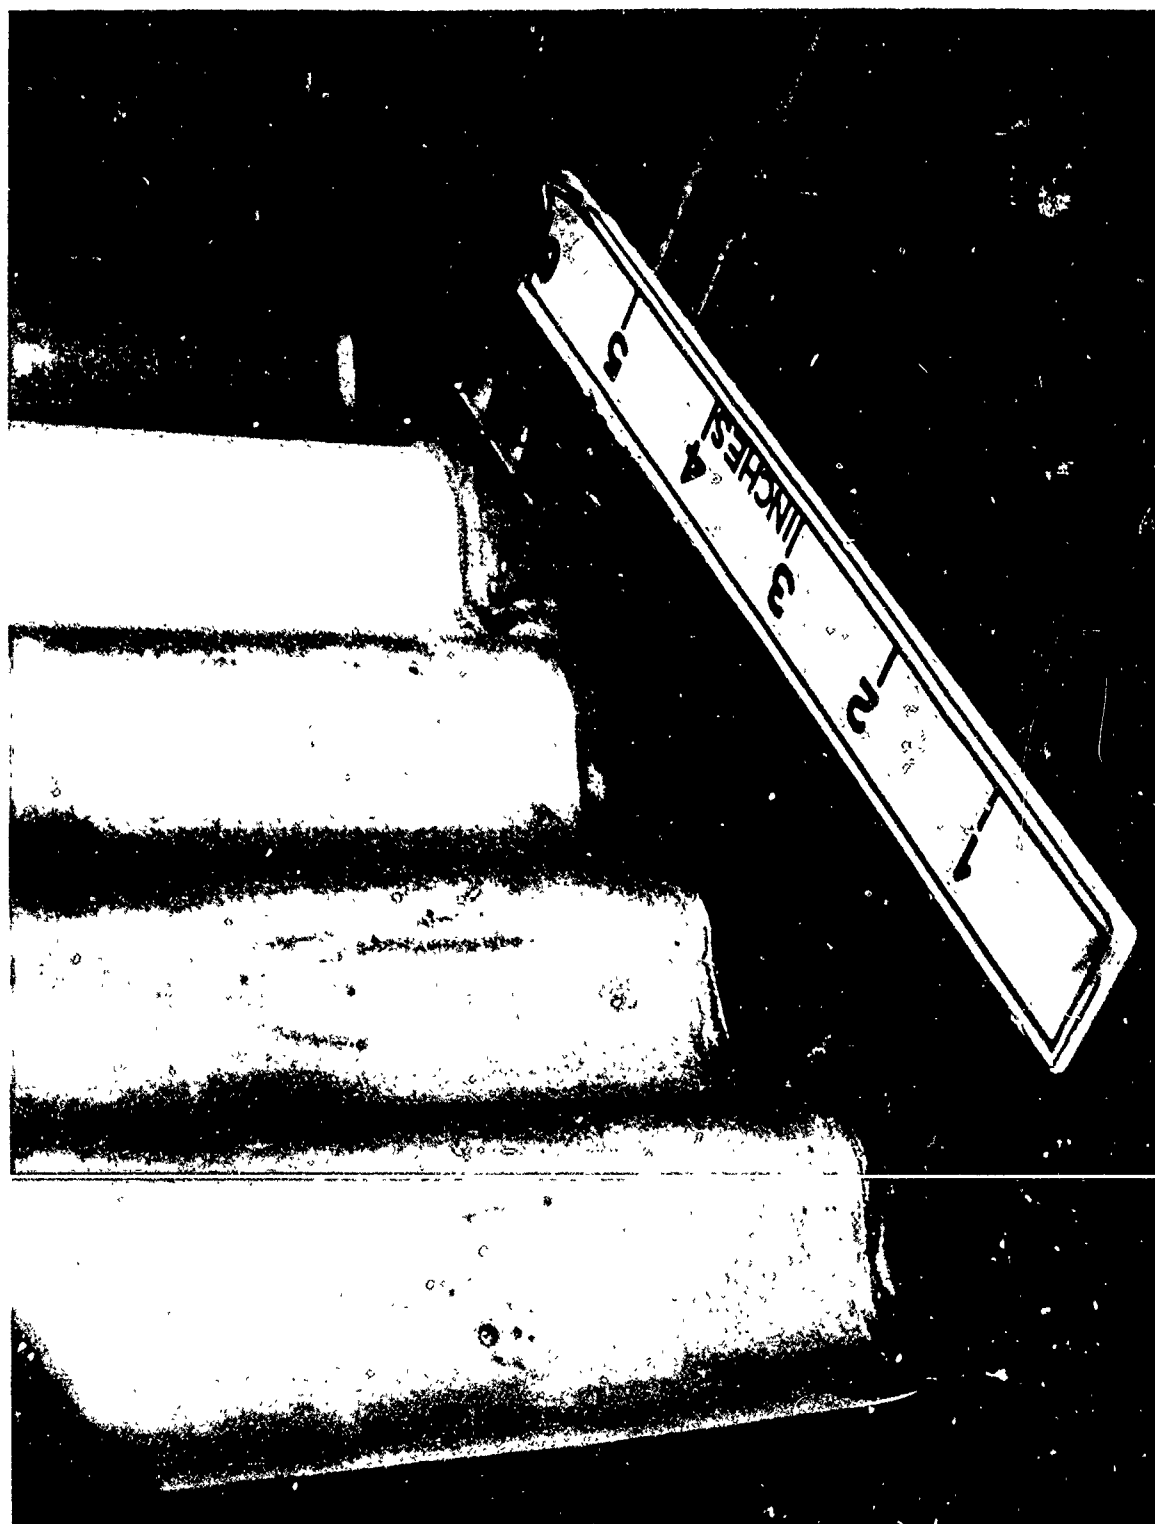
Convair Print 66531
Figure E-19 -- STATIC FAILURE OF 29-01012 PANEL; Due to Weld Failure,
4 psi at 72,000 lbs & 800F.

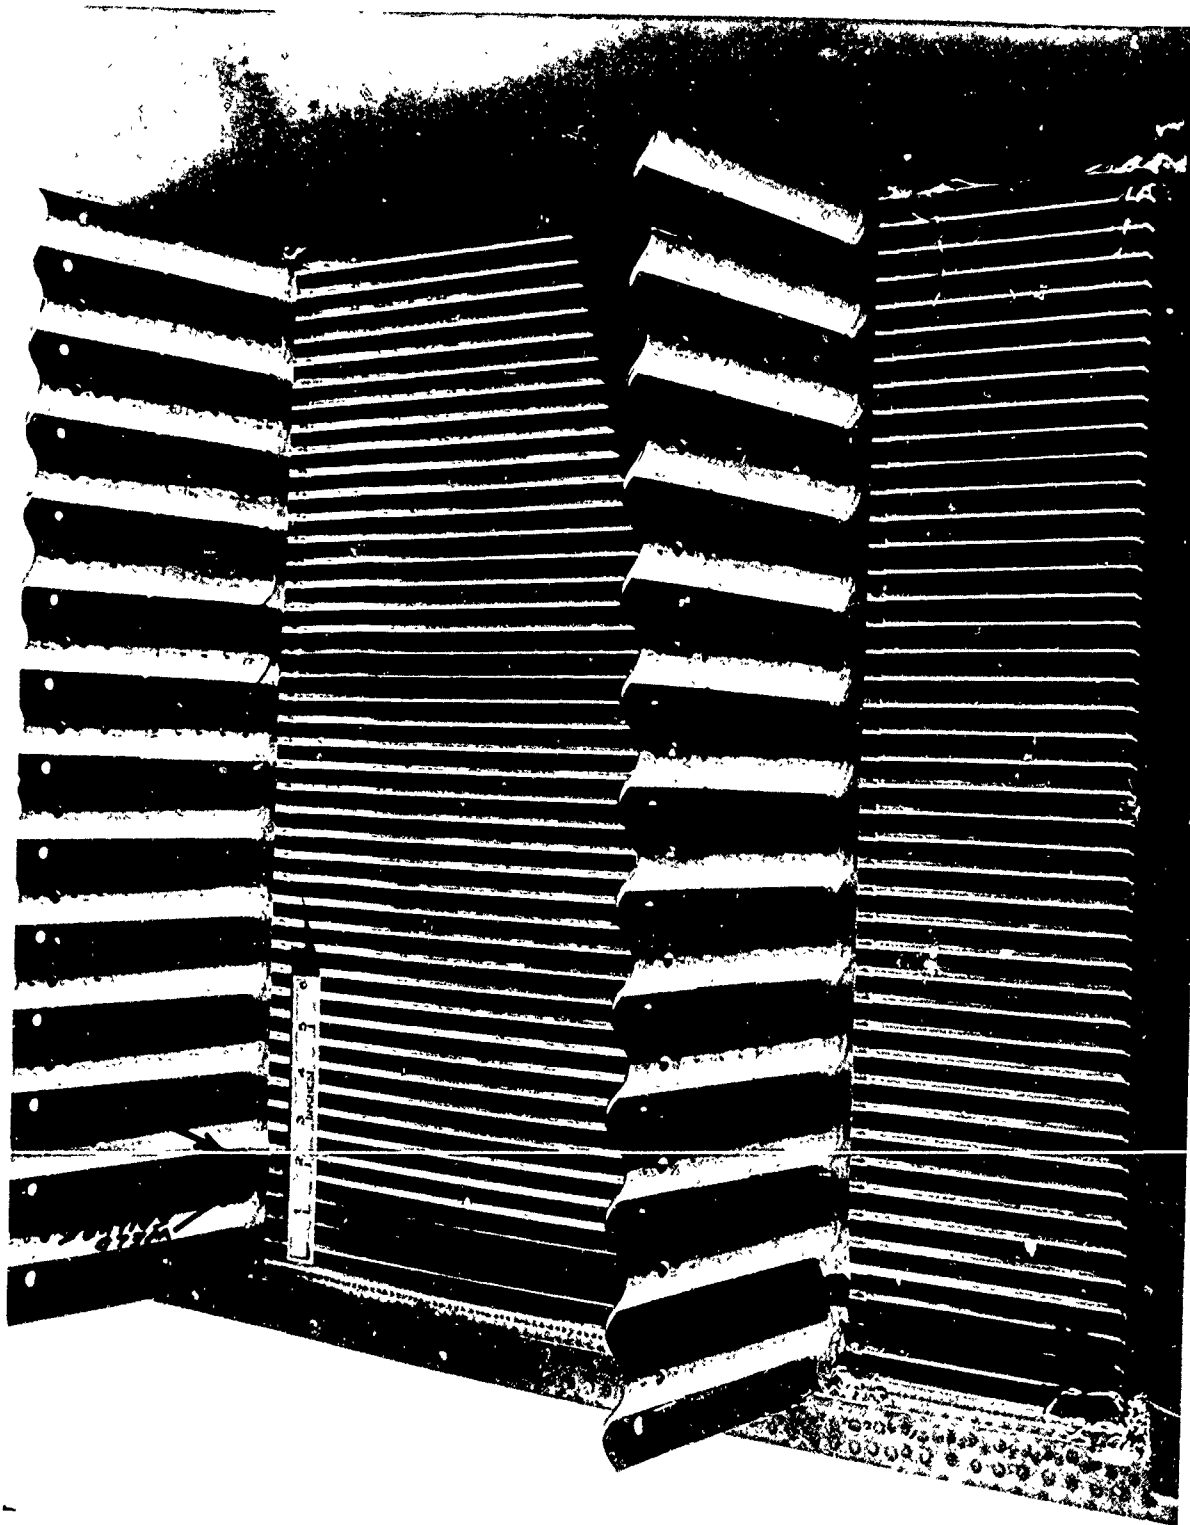
Figure E-20 — STATIC FAILURE OF 29-01012 PANEL; 4 psi at 72, 000 lbs & 800F.

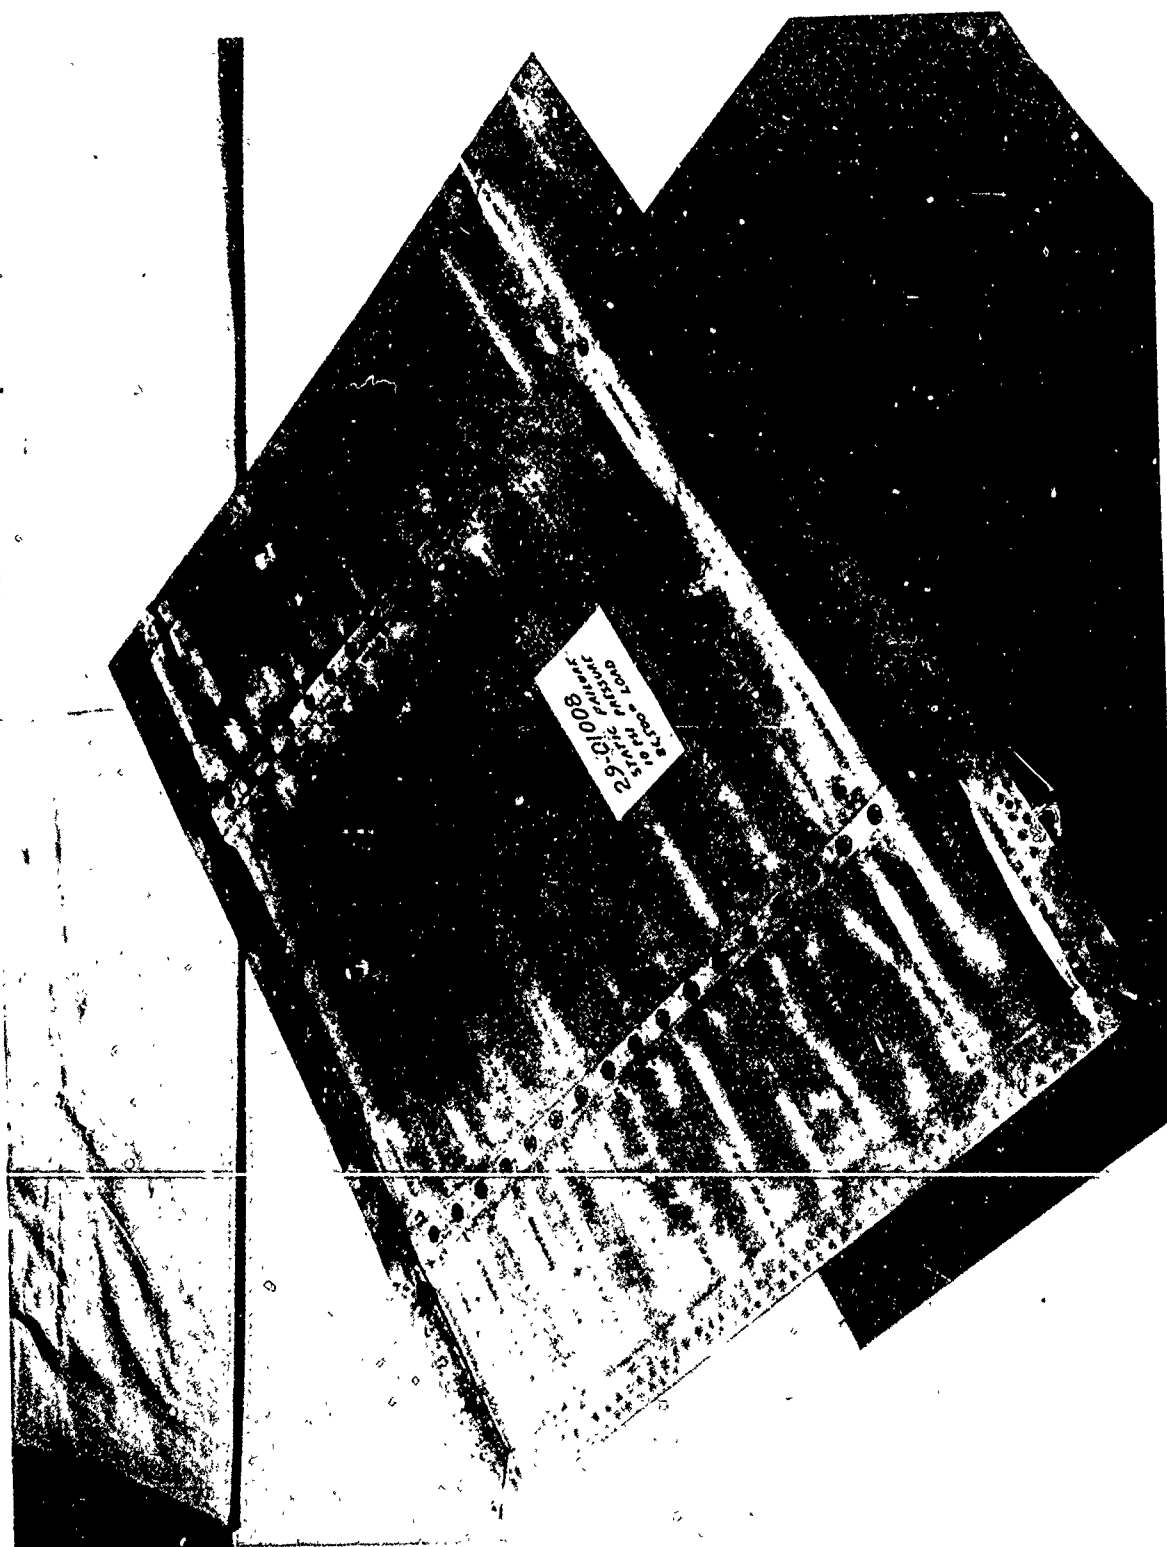
Convair Print 66374
Figure E-21 -- STATIC FAIL RE OF 29-01008 PANEL; Spar and Skin Buckling,
10 psi at 86, 90 lb & 800F.

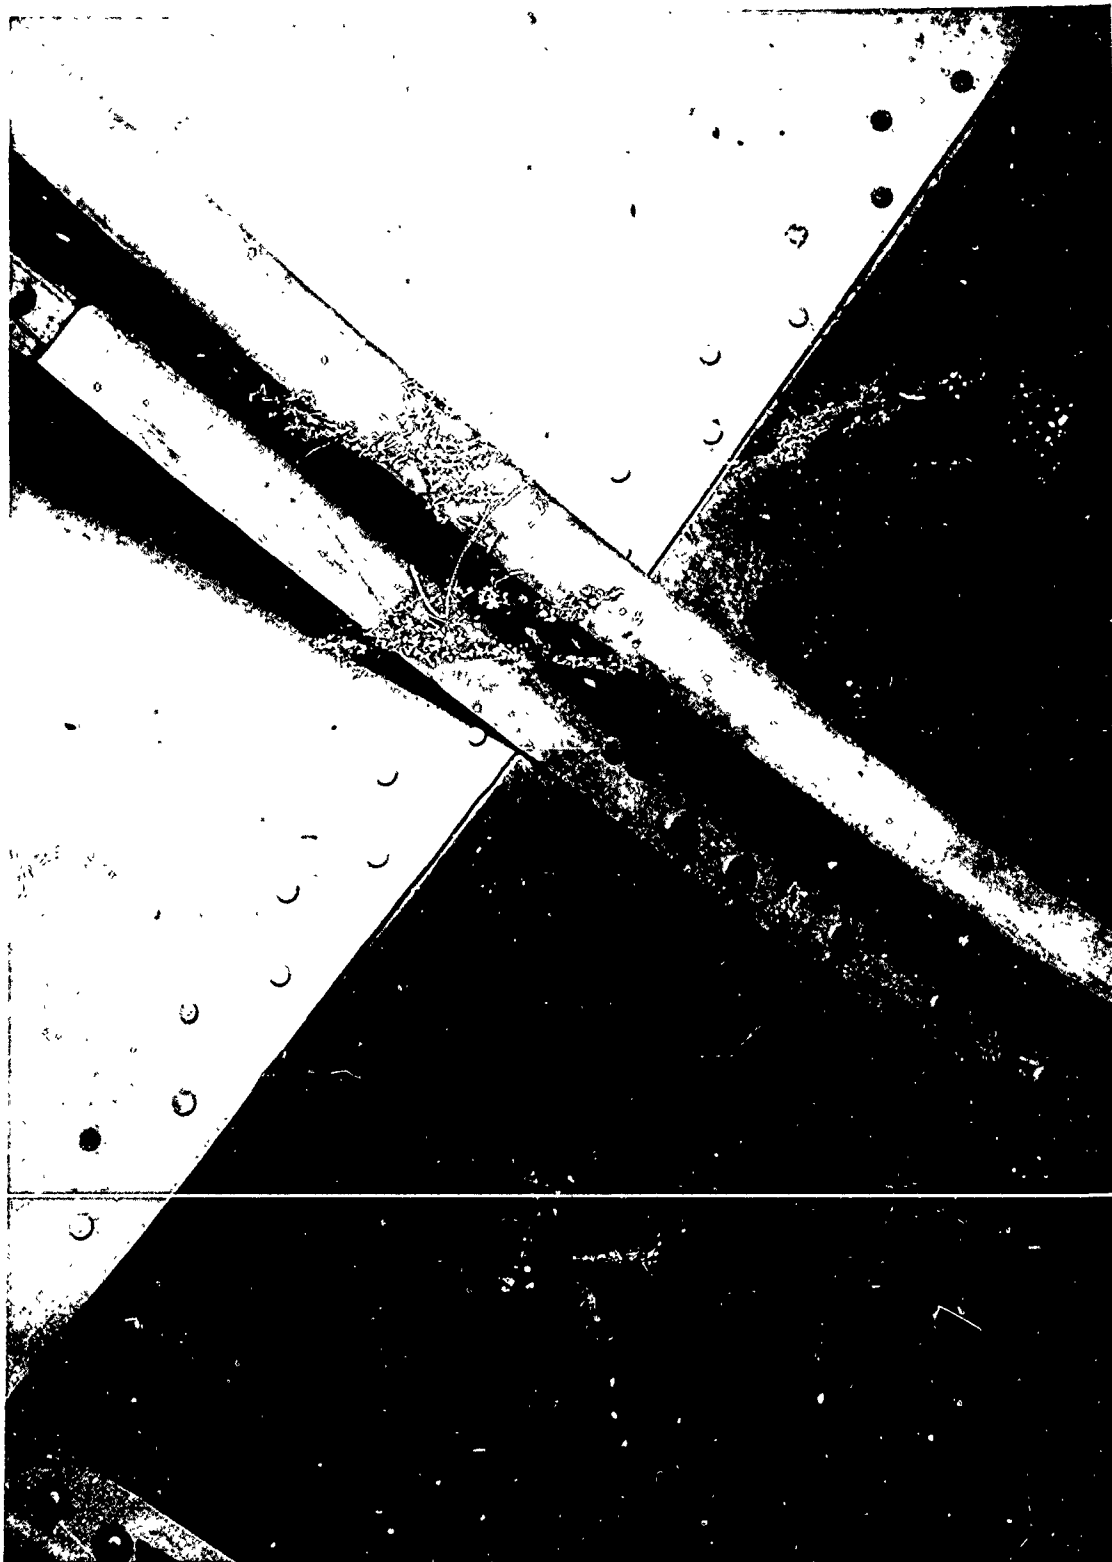
Figure F-25 — DETAIL VIEW SHOWING PARTIALLY FAILED RIB.

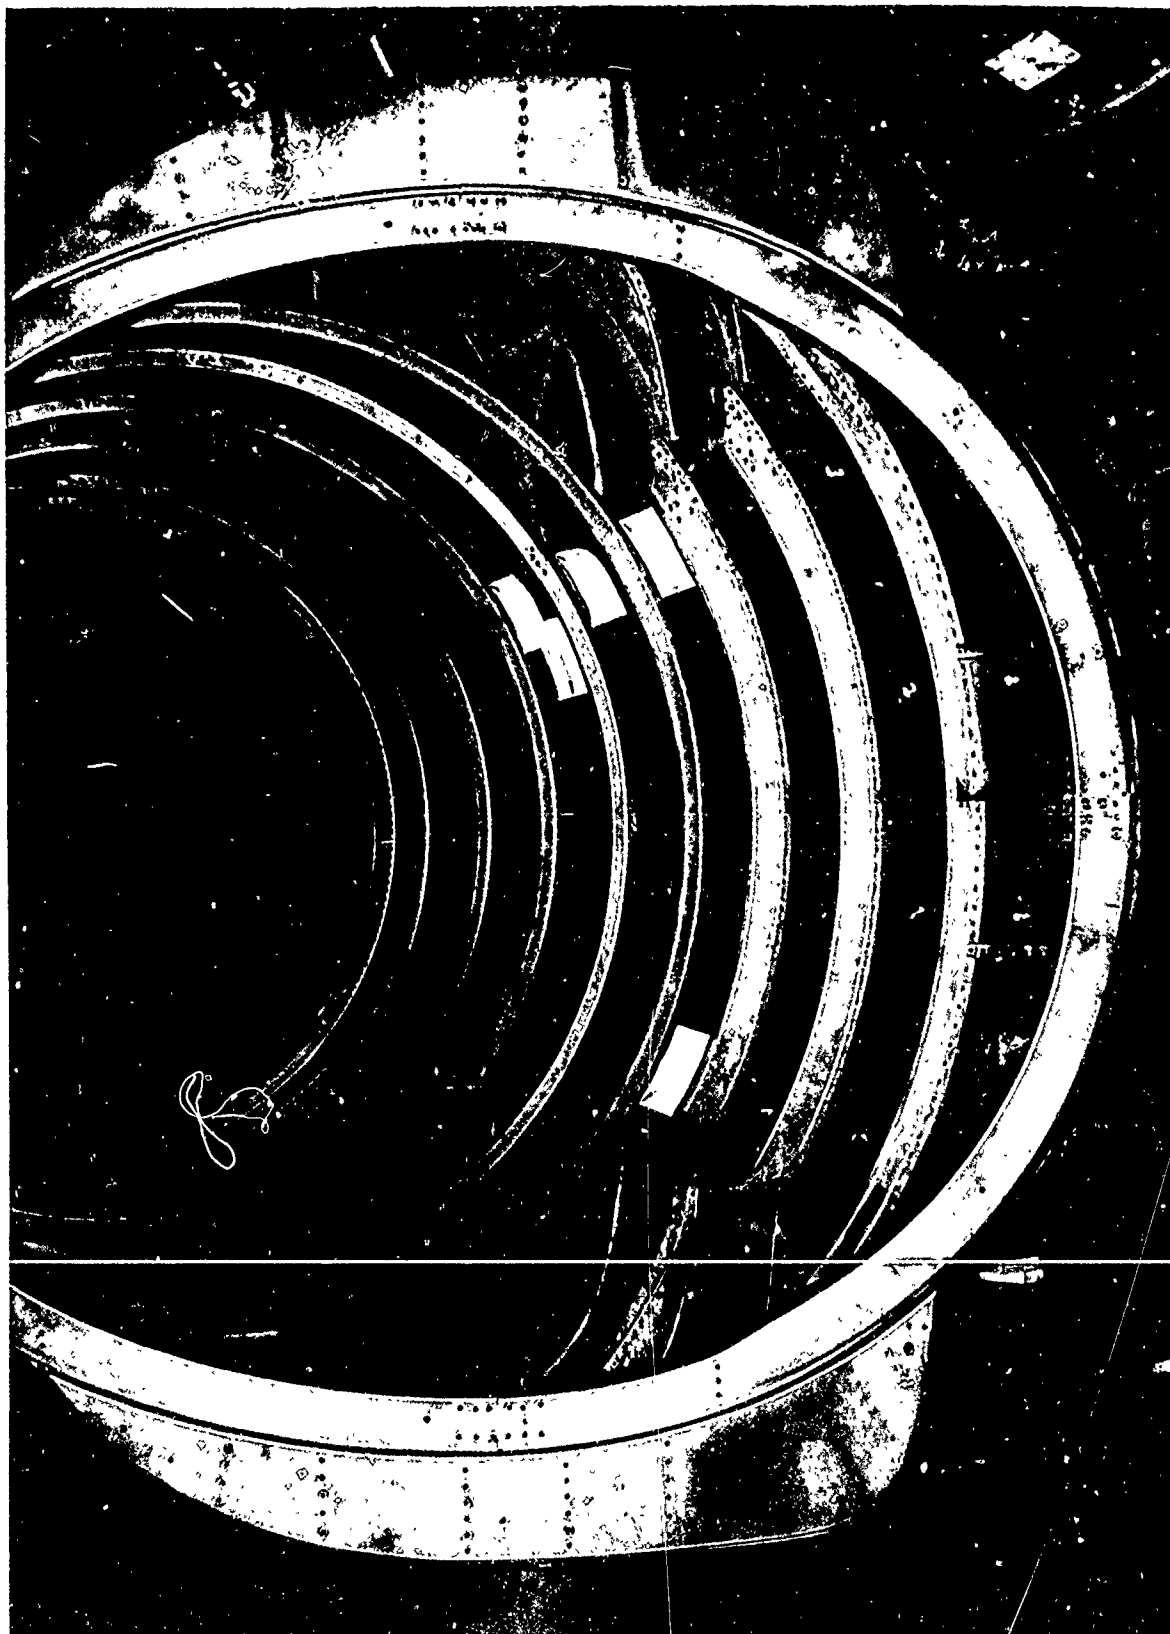
Figure F-26 — OVERALL VIEW SHOWING RELATIVE LOCATIONS OF
FAILED RIBS AND TORN OUT SECTION.

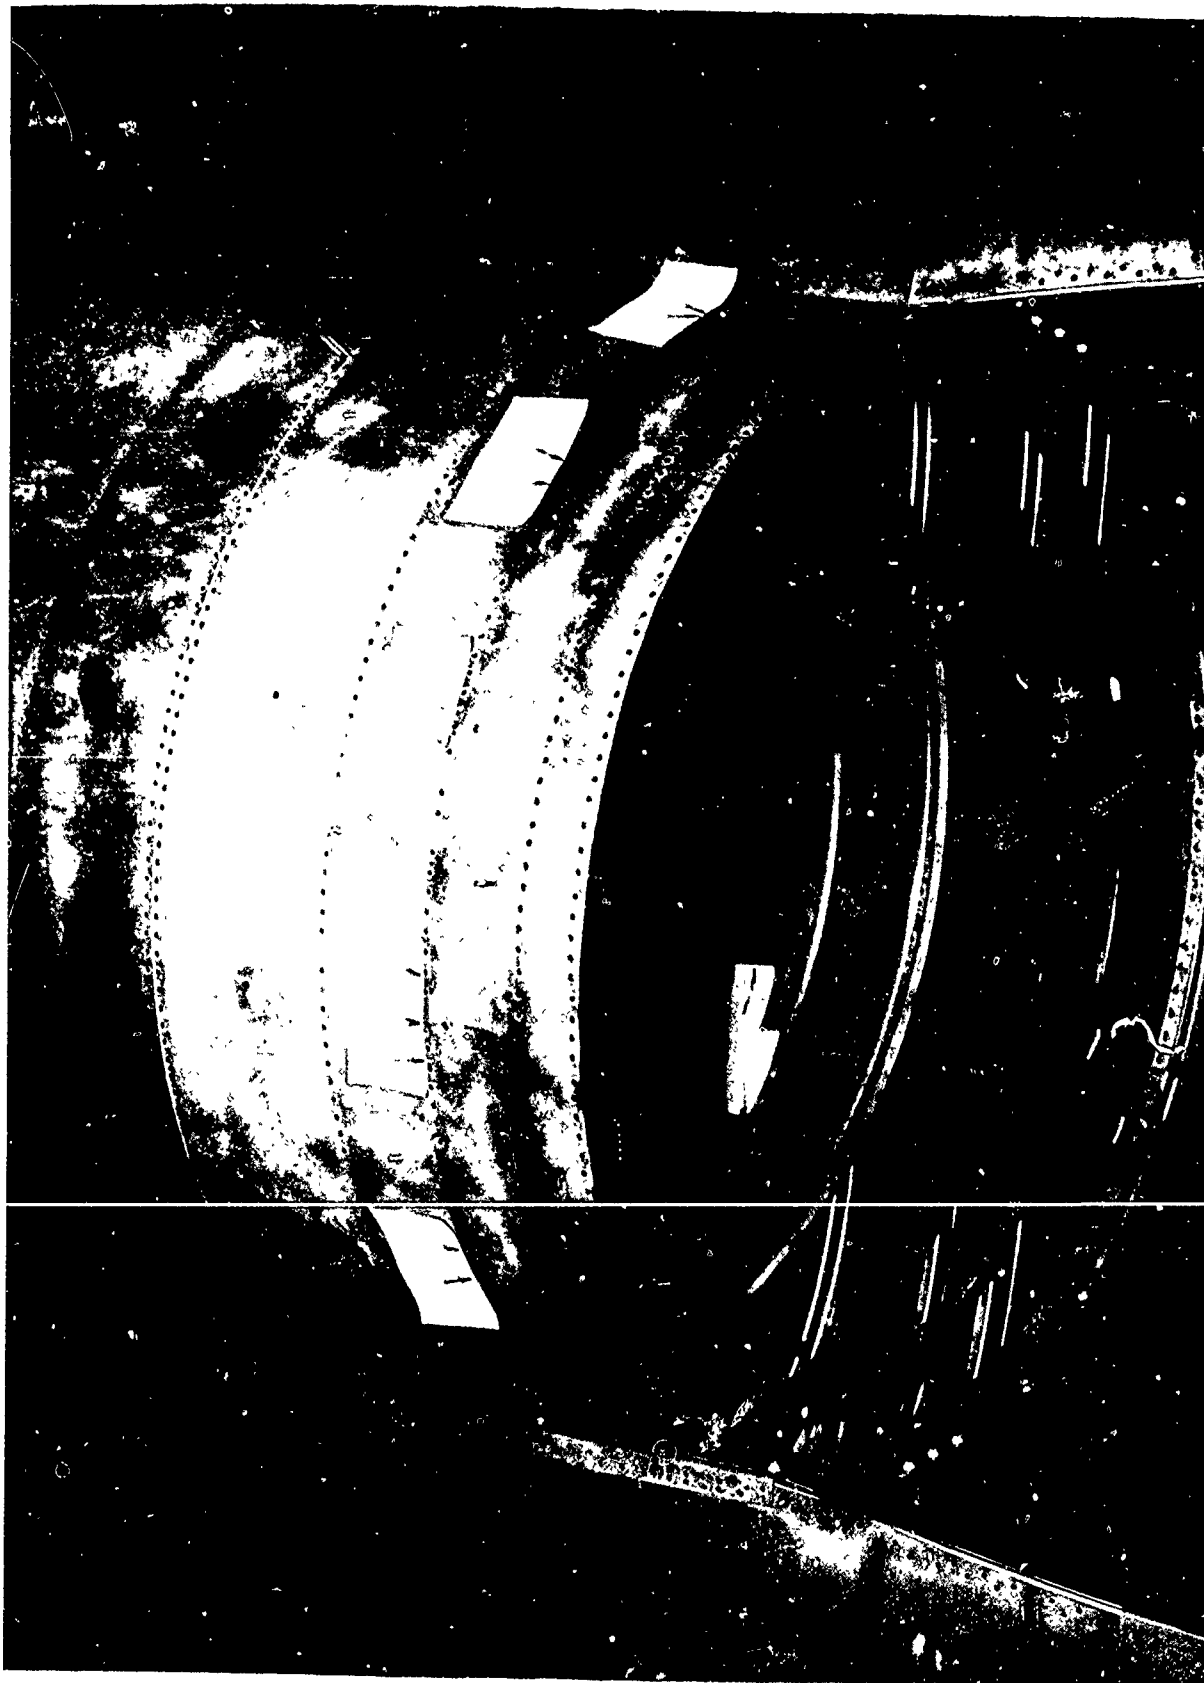
Convair Print 65951
Figure F-27 - OVERALL VIEW SHOWING SKIN CRACKS AND THEIR LOCATION RELATIVE TO THE
FAILED RIBS AND TORN OUT SECTION.

Several cracks started in the skin adjacent to rivets near the nozzle end of the Tail Cone during the 125% limit load testing at 800 F. These are shown in an over-all view in Figure F-27 (page 315). Figures F-28, F-29, and F-30 (pages 316, 317 and 318) show details of these cracks; left, middle, and right, respectively, as compared to Figure F-27. The cracks were located in a lightly loaded area (48 pounds per load point) while diametrically opposite there were no cracks with up to 101 pounds per load point. An investigation showed that the cracked skin had a hydrogen content of about 190 PPM. This was about the highest of all skins used on the Tail Cone. The load points adjacent to these cracks were then moved

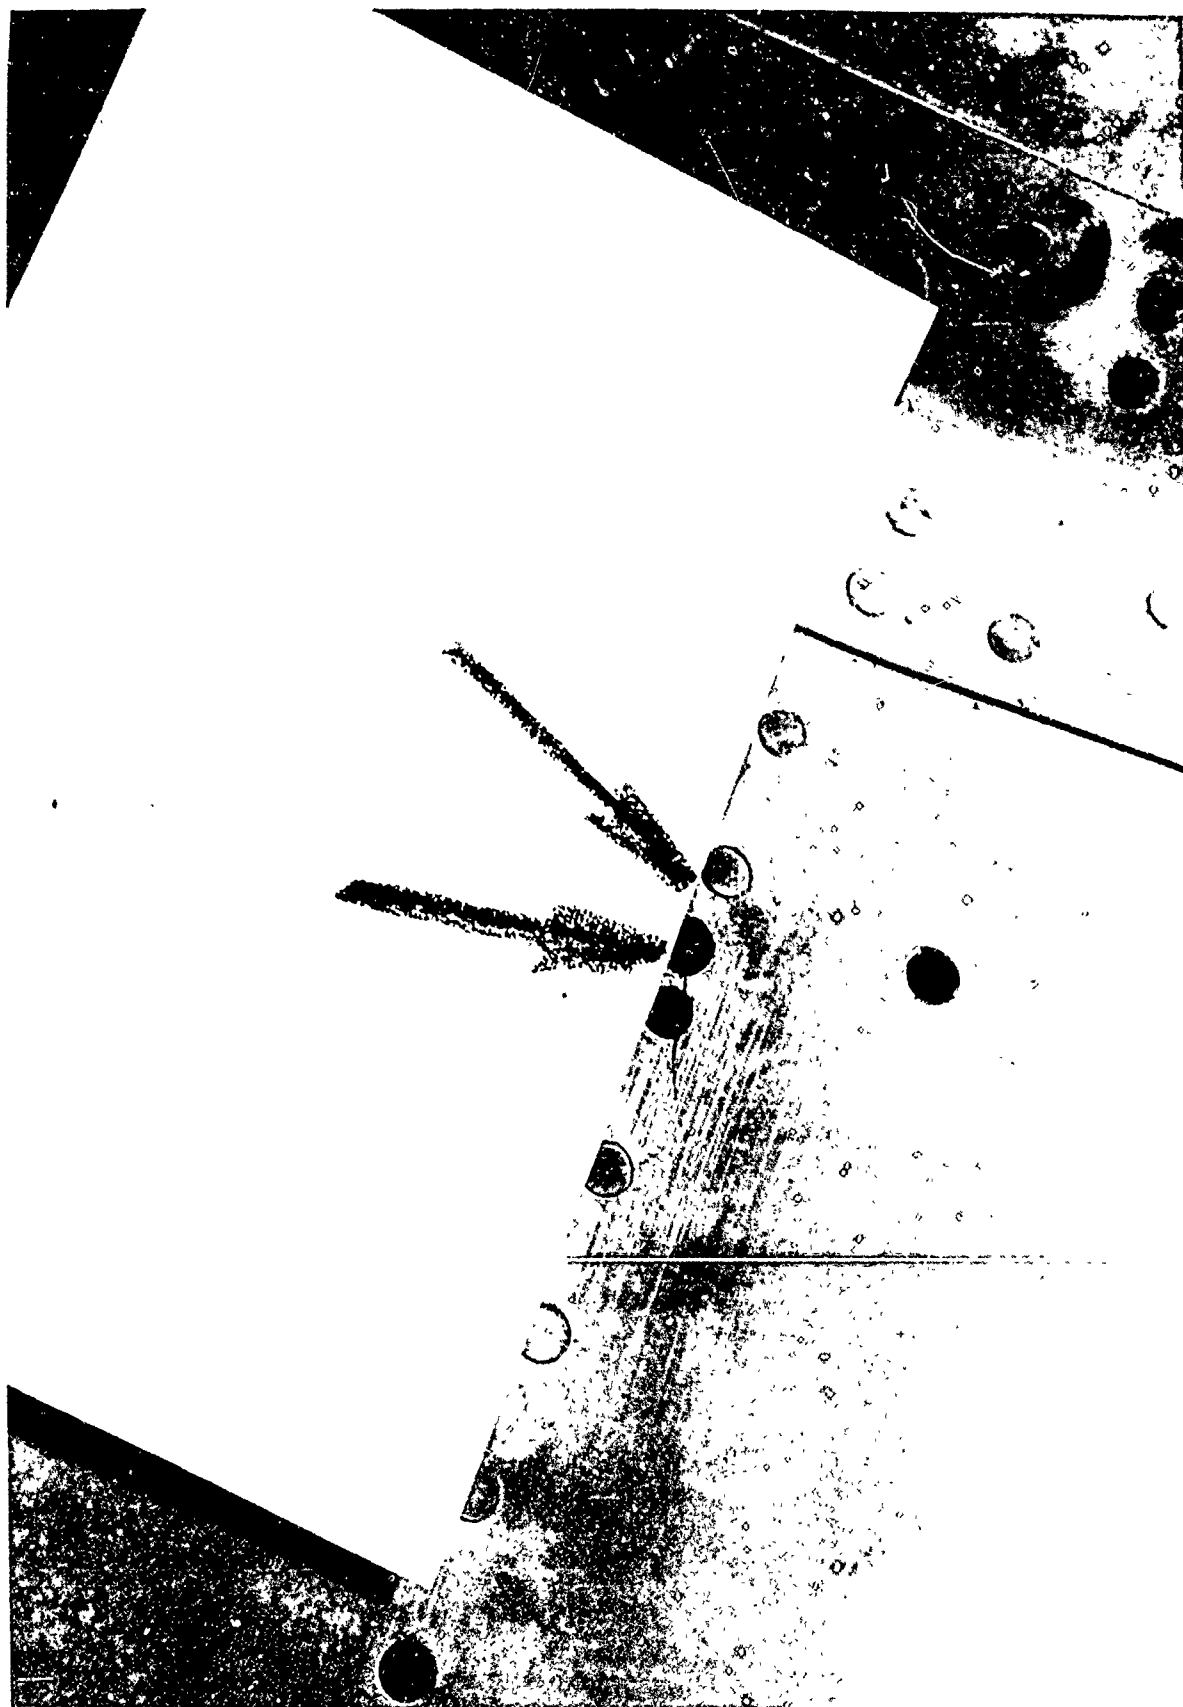
Figure F-30 — DETAIL VIEW SHOWING SKIN CRACKS; Original Load-Point Holes are Away From Rivet Pattern, Relocated Holes are Between Rivets.
